Pre-Purchase Car Inspection Platform

## VEHICLE INSPECTION REPORT

# 2025 Toyota Allion

**KDE567K**

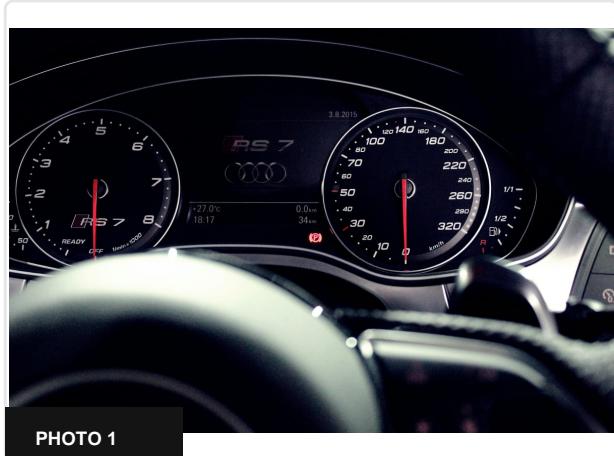
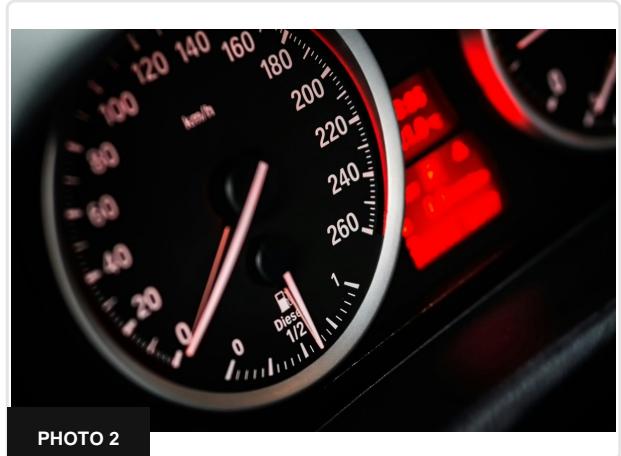
### INTERIOR PHOTOS

Component	Rating	Condition	Notes
Seats & Upholstery	4/5	Excellent	N/A
Electronics	4/5	Excellent	VVZXDDg
Carpet & Flooring	4/5	Excellent	zb
Trunk & Storage	4/5	Excellent	xcbBZ

Interior is well-maintained with normal wear patterns. All essential functions operate correctly.
